# Evidence of Performance

### Test Report

No. 16-000936-PR02

| <b>Product</b> | <b>Low-E Vacuum insulating glass unit</b> |

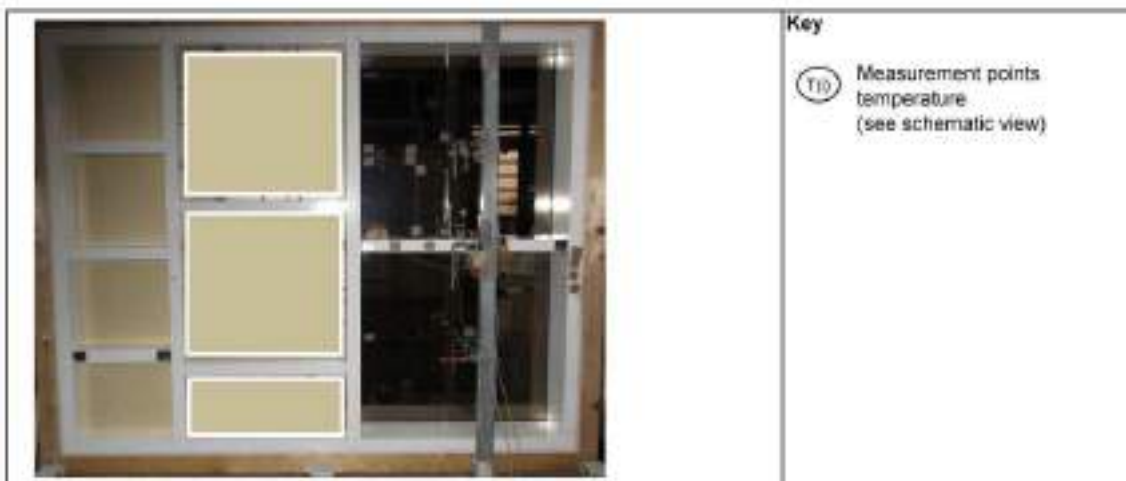
#### 1: VIG 1000 mm x 1000 mm

- 1: Temperature in center of VIG, on distance piece
- 2: Temperature in center of VIG, between distance pieces
- 3: Temperature in center of VIG, between distance pieces
- 4: Temperature at left edge of VIG, near to distance piece
- 5: Temperature at left edge of VIG, between distance pieces
- 6: Temperature at bottom edge of VIG, near to distance piece
- 7: Temperature at bottom edge of VIG, between distance pieces
- 8: Temperature at corner of VIG, near to distance piece
- 9: Temperature at corner of VIG
- 10: Temperature in center of transom
- 12: Temperature in center of VIG, between distance piece
- 13: Temperature at top edge of VIG, between distance pieces
- 14: Temperature at left edge of VIG, between distance piece

**Table:** Measured values of surface temperatures in °C by thermal load with +80°C (external side)

T1, T2, T3: Surface temperature at measurement points T1, T2, T3 ... (on the internal surface)

No malfunctions were detected.

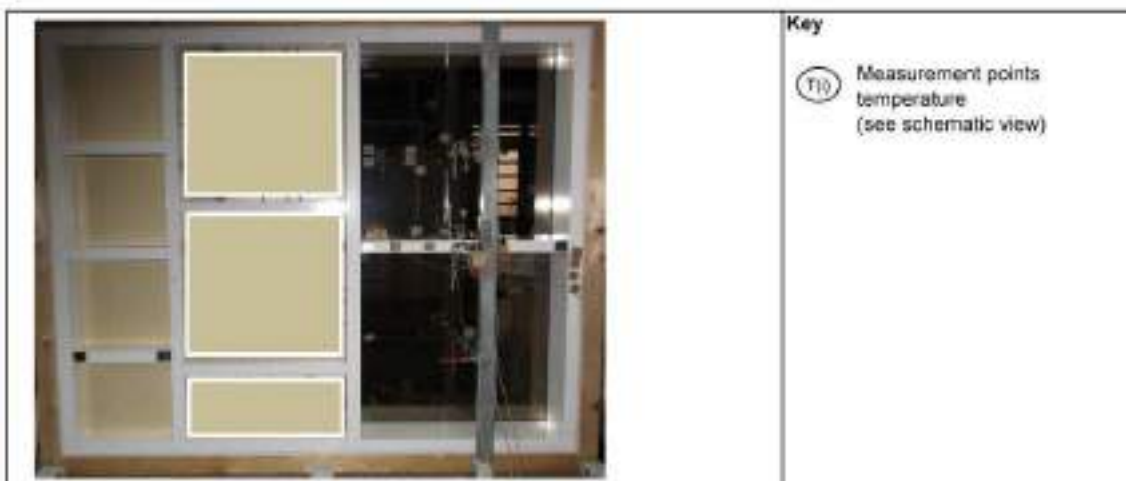
#### 1: VIG 1000 mm x 1000 mm

- 1: Temperature in center of VIG, on distance piece
- 2: Temperature in center of VIG, between distance pieces
- 3: Temperature in center of VIG, between distance pieces
- 4: Temperature at left edge of VIG, near to distance piece
- 5: Temperature at left edge of VIG, between distance pieces
- 6: Temperature at bottom edge of VIG, near to distance piece
- 7: Temperature at bottom edge of VIG, between distance pieces
- 8: Temperature at corner of VIG, near to distance piece
- 9: Temperature at corner of VIG
- 10: Temperature in center of transom
- 12: Temperature in center of VIG, between distance piece
- 13: Temperature at top edge of VIG, between distance pieces
- 14: Temperature at left edge of VIG, between distance piece

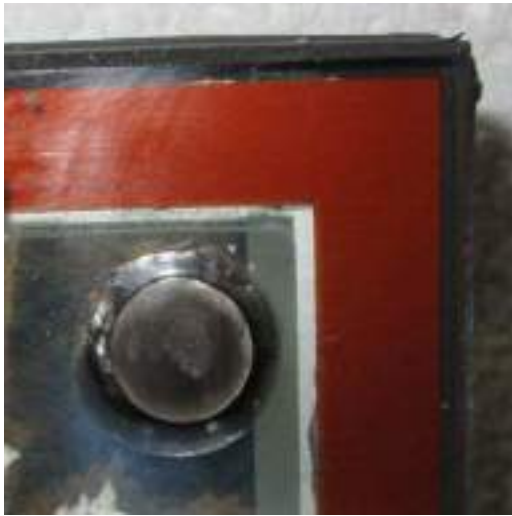
Fig. 3 Photo of the evacuation port (created by the ift).

| Type, Manufacturer | See attachment 1, Fig. 3 |
